Service Bulletin

TAT SB11-06, Revision None

Issued: 09/29/2011

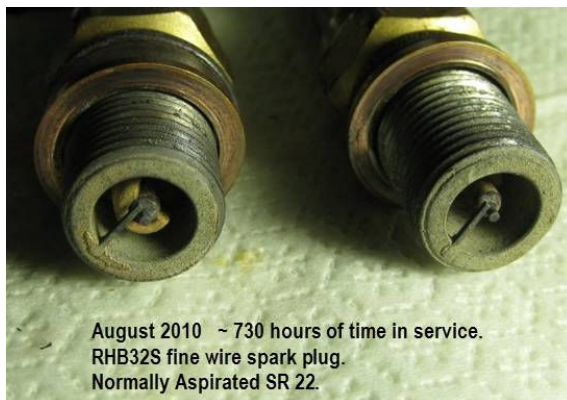
Figure 1. An example of two cracked fine wire RHB32S spark plugs from one engine.

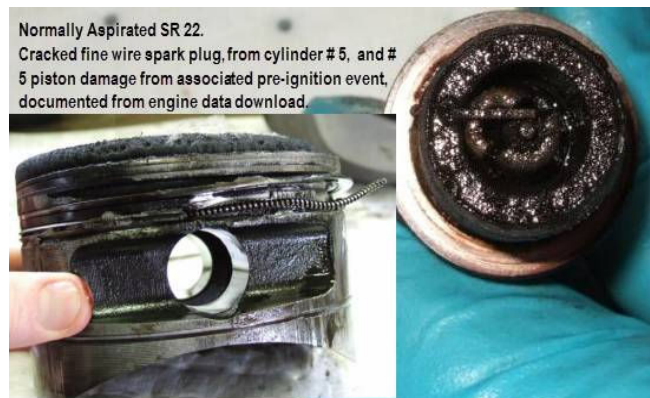
Figure 2. See associated engine monitor data in Figure 4, below.

Figure 2 (above) is an example of another cracked RHB32S fine wire plug and associated damage to the piston from preignition. The preignition on cylinder # 5 is clearly documented in the downloaded engine data. See Figure 4.

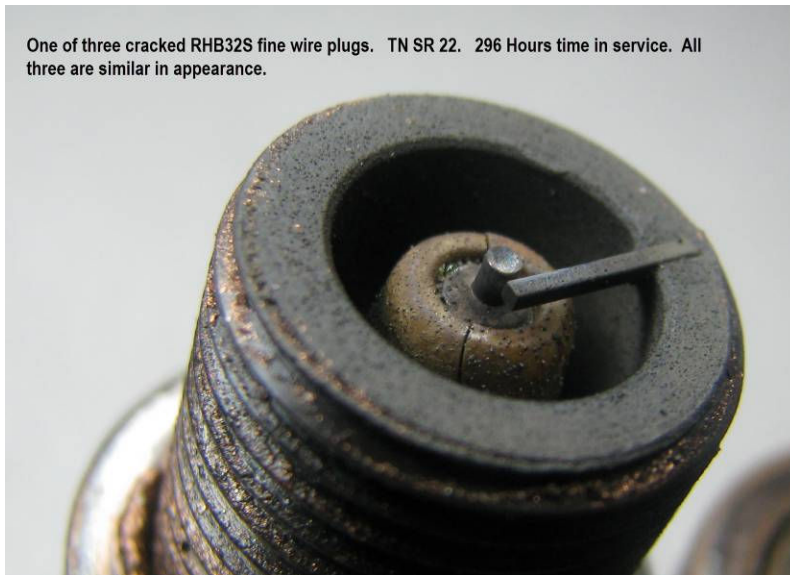
Figure 3.

One of three cracked RHB32S fine wire plugs. TN SR 22. 296 Hours time in service. All three are similar in appearance.

The cracks in this example are obvious. However, in some instances, cracks may only be visually detectable after the spark plugs are cleaned in accordance with normal shop practices.

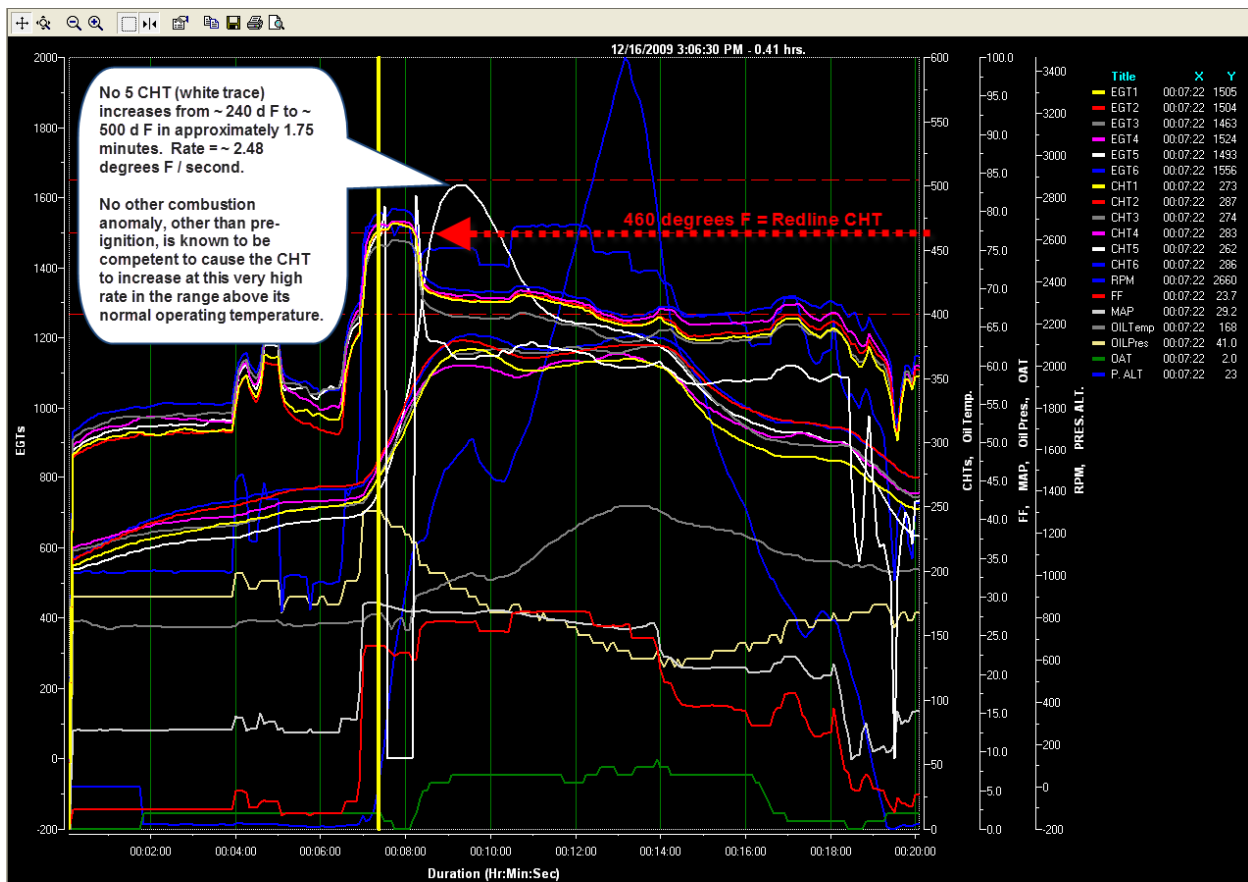
Figure 4.

A cracked spark plug ceramic, in some cases, results in a loose piece of the ceramic that remains in or is lodged in the spark plug cavity. Because it cannot “heat sink” in the intended normal manner, the small ceramic piece will then increase in temperature and eventually will glow hot enough to ignite the fuel air charge early in the compression stroke, well in advance of the normal spark event. This preignition at normal cruise to high power settings creates extremely high CHTs in a very short time, on the order of 30-60 seconds. See Figure 4 which details this event in connection with the damaged cylinder shown in Figure 2, above. This rapid (≈ 1.5 to 3.5 degrees F / second) increase in cylinder head temperatures, if not corrected immediately, may cause, and has caused destruction of piston rings and pistons as shown in Figure 2, above. This piston and ring damage will normally cause the crank case to become pressurized from the pumping action of the piston and oil can then be forced out of the crank case breather until the engine oil pressure drops to zero. This may lead to engine stoppage and a forced landing.

CORRECTIVE PILOT ACTION: In the event a very rapid and unusual rise in any CHT is observed, the pilot should (altitude permitting) immediately reduce the power with the throttle to idle for 3 to 5 seconds and then advance the power with a full rich mixture to the minimum power level required to maintain flight. Thereafter, land at the first available opportunity and ground the aircraft until the cause is determined and corrected. Performing this corrective action before the CHT exceeds the normal engine redline CHT (460 degrees F) will likely, but not necessarily, prevent significant damage to the engine.
