Service Bulletin

TAT SB08-01

Issued: February 8, 2008
Model SR22 w/ Tornado Alley
Turbo, Inc. Turbonormalizer
installed pursuant to Engine
Technologies, Inc. STC
SA10588SC on Cirrus Design
Corporation Model SR 22 aircraft

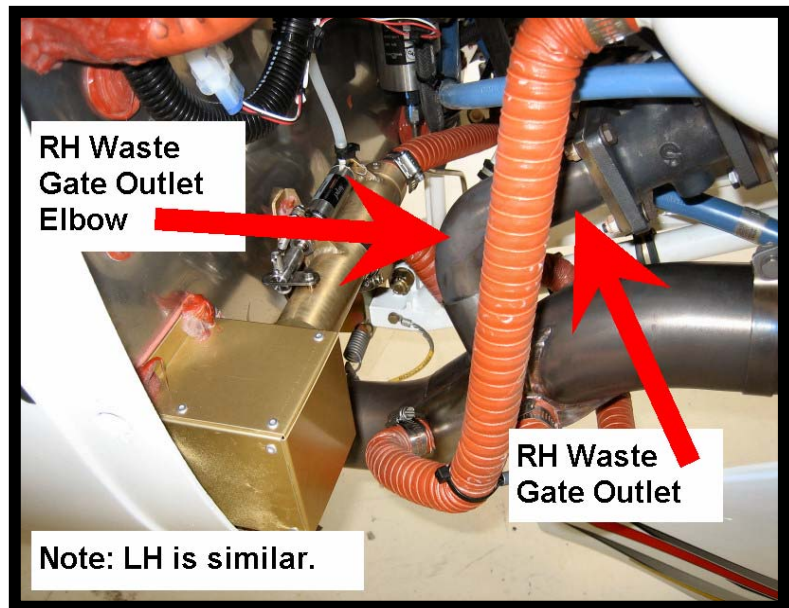
Figure 1. Right side shown.
Left Side Similar.

- b. Visually locate the wastegate outlet on the aft side of the right hand wastegate. See Figure 1. Disconnect the heater hose clamp and hose from the intercooler to facilitate inspection and access.

- c. Visually inspect the right angle exhaust elbow and the area where the elbow inserts into the tailpipe, for any signs of a crack in the weld of the vertical receptacle in the tailpipe into which the short leg of the right angle elbow is inserted. If any cracks are observed, then contact Tornado Alley Turbo, Inc. for replacement parts before return to service or further flight.

- i. Measure the length of the elbow from the previously applied reference mark to the end of the long leg of the elbow.
 - j. If this measurement is greater than 1.00", shorten the elbow so that the engagement, when re-installed, will be no more than 1.10" and not less than 1.00" as measured from the reference mark.

- k. If the engagement length is less than 1.00" but is more than 0.90" then simply re-install the elbow. If the engagement is less than 0.90" then contact Tornado Alley Turbo, Inc., for a replacement elbow.

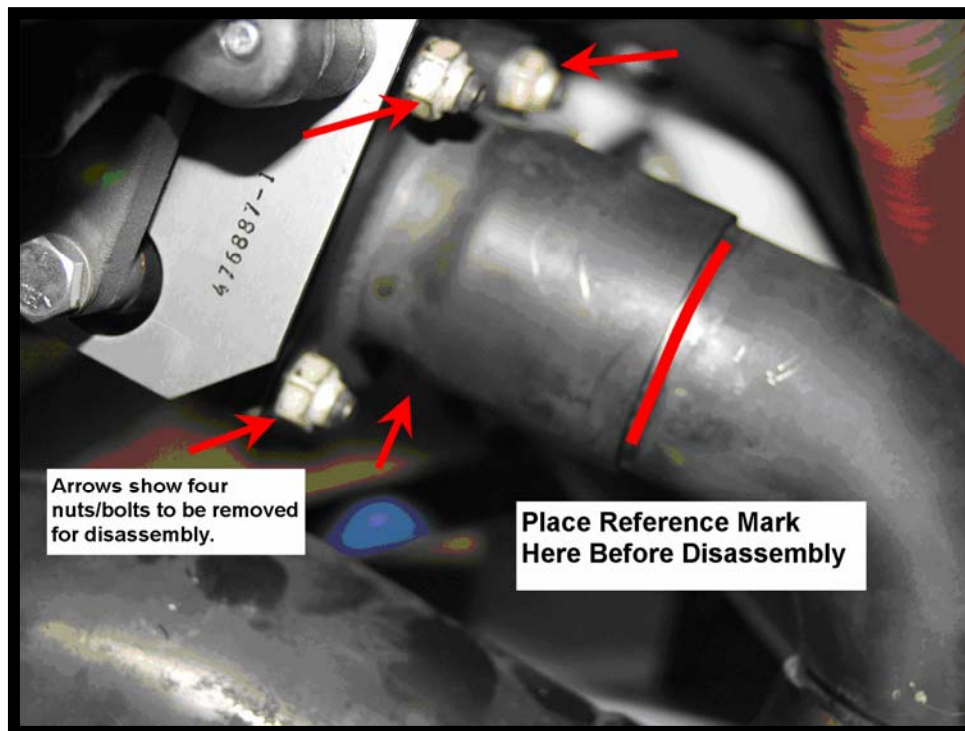
Figure 2.
Left side.
Showing where to place reference mark before disassembly.

- d. Clean the area where the elbow is inserted into the wastegate outlet tube.
 - e. Mark the exhaust elbow at the aft end of the wastegate outlet tube.
