Service Bulletin

TAT SB10-02, Revision B

Model SR22 w/ Turbonormalizer

Installed per STC SA10588SC

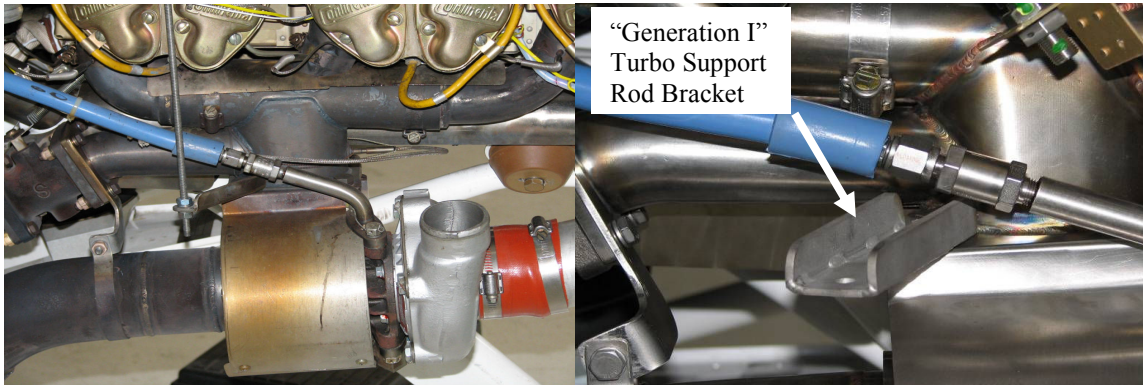
There are three versions of the right hand exhaust. The first generation right hand exhaust incorporates a "bridge" style support rod bracket from the exhaust's turbocharger flange to the turbo support rod. Subsequent generations of the right hand exhaust incorporate a tab on the outboard edge of the exhaust turbocharger flange. An angle is bolted to the tab and the angle is used to hold the turbo support rod bracket and turbo support rod. The right hand exhaust without the tab for the angle is referred to in this service bulletin as the "Generation I" exhaust. All other right hand exhaust systems are referred to, for this service bulletin, as "Generation II" exhaust.

“Generation I” exhaust with bridge style turbo support rod bracket. Rod not shown in second picture.

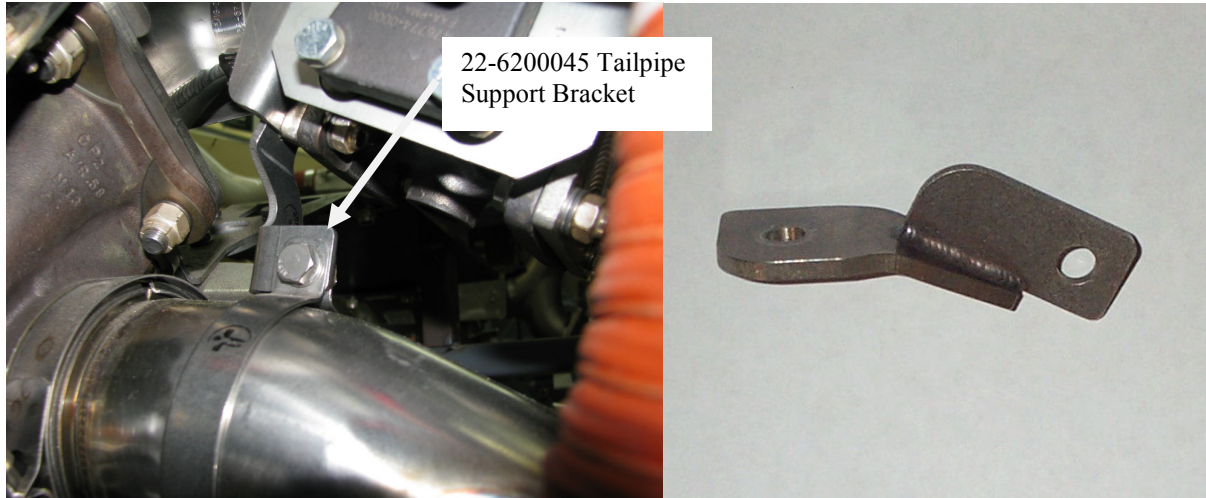
Installation of left hand tailpipe support bracket

Old style (welded) left hand tailpipe support bracket

3. To replace the left hand tailpipe bracket remove the existing tailpipe bracket. Install 22-6200045 bracket with existing hardware. Slide flat tailpipe band clamp into position and attach to 22-6200045 bracket with existing hardware. If the locknuts do not continue to show resistance to turning, replace them with new MS21045C4 nuts. Tighten nuts to 70 in-lb.

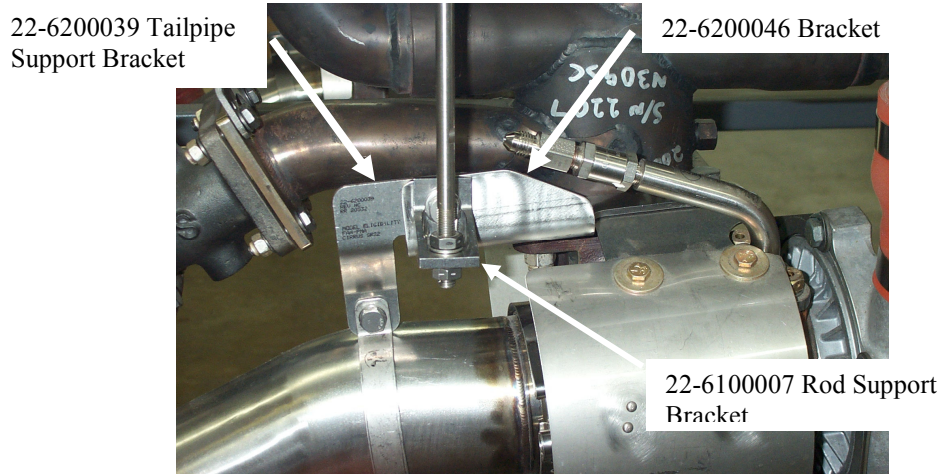
Installation of right hand tailpipe support bracket on “Generation I” right hand exhaust

4. (a) For “Generation I” right hand exhaust:
To replace the right hand tailpipe bracket remove the existing tailpipe bracket. Install AN4C11A bolts in place of the bolts removed from the wastegate flange. Tighten nuts to 70 in-lb (if the locknuts do not continue to show resistance to turning, replace them with new MS21045C4 nuts). Cut the safety wire and remove the lower nut holding right hand turbo support rod. Slide the rod up and out of the way to gain access to the bolt holding the lower rod support. Remove the two outboard turbo flange bolts and the lower rod support channel bracket from the turbo flange. Install a 22-6200046 bracket on the outboard portion of the turbo flange on top of the turbo heat shield support with two AN6C13A bolts and existing washers and

nuts. If the nuts do not continue to show resistance to turning, replace them with new MS21045C6 nuts. Tighten MS21045C6 nuts to 275 in-lb. Install a 22-6100007 rod support bracket on the outboard side and a 22-6200039 tailpipe bracket to the inboard side of the 22-6200046 bracket with an AN5C7A bolt. Install washer and locknut. If the locknut does not continue to show resistance to turning, replace it with new MS21045C5 nut. Tighten nut to 180 in-lb after reinstallation and alignment of turbo support rod. Reinstall turbo support rod, verify that rod is properly aligned and tighten lower nut to 100 in-lb. Resafety lower turbo support rod nuts. Slide flat tailpipe band clamp into position and attach to 22-6200039 bracket with existing hardware. If the locknut does not continue to show resistance to turning, replace it with new MS21045C4 nut. Tighten nut to 70 in-lb.

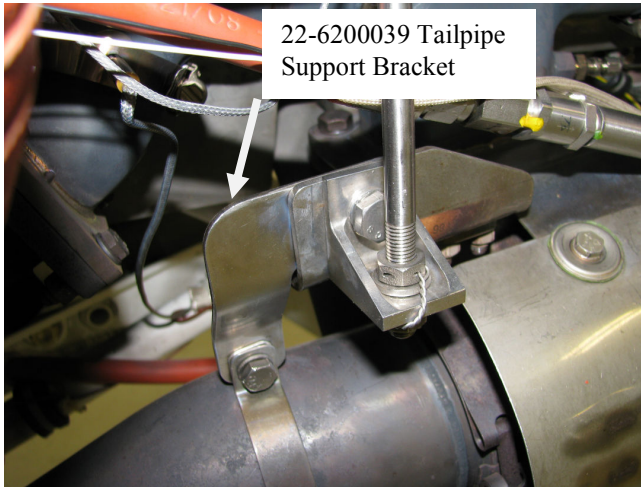
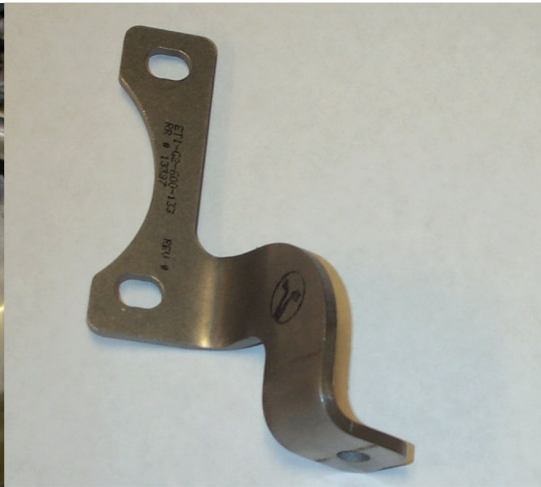
Installation of right hand tailpipe support bracket on
"Generation II" exhaust

Old style right hand tailpipe support bracket

To replace the right hand tailpipe bracket remove the existing tailpipe bracket. Install AN4C11A bolts in place of the bolts removed from the wastegate flange. Tighten nuts to 70 in-lb (if the locknuts do not continue to show resistance to turning, replace them with new MS21045C4 nuts). Cut the safety wire and remove the lower nut holding right hand turbo support rod. Slide the rod up and out of the way to gain access to the bolt holding the lower rod support. Remove the AN5C6A bolt holding the rod support to the angle bracket attached to the turbo flange. Replace the AN5C6A bolt with an AN5C7A bolt. Place a 22-6200039 tailpipe bracket on the inboard side of the angle bracket and install washer and locknut. If the locknut does not continue to show resistance to turning, replace it with new MS21045C5 nut. Tighten nut to 180 in-lb after reinstallation and alignment of turbo support rod. Reinstall turbo support rod, verify that rod is properly aligned and tighten lower nut to 100 in-lb. Resafety lower turbo support rod nuts. Slide flat tailpipe band clamp into position and attach to 22-6200039 bracket with existing hardware. If the locknut does not continue to show resistance to turning, replace it with new MS21045C4 nut. Tighten nut to 70 in-lb.
