# **Service Instructions**

TAT SI08-01, Rev. A

Model SR22 w/ Turbonormalizer

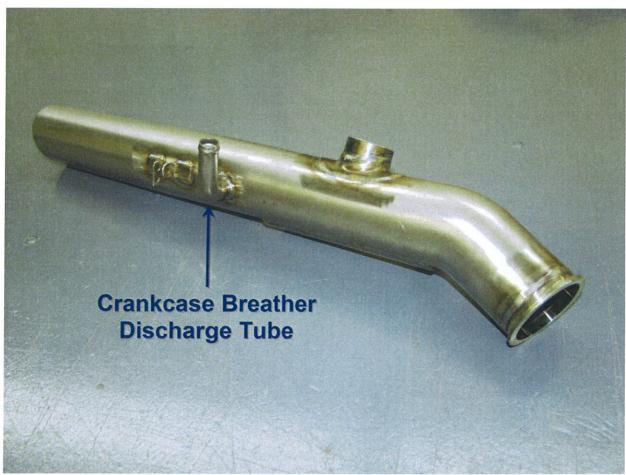
Figure 1 shows the Left Side SR22 tailpipe with the Crankcase Breather Discharge Tube.

- Gain access to the left hand tailpipe by removing the upper and lower portions of cowl.
- Loosen clamp on Crankcase Oil Breather Hose where it connects to the left hand tailpipe (see Figure 1).

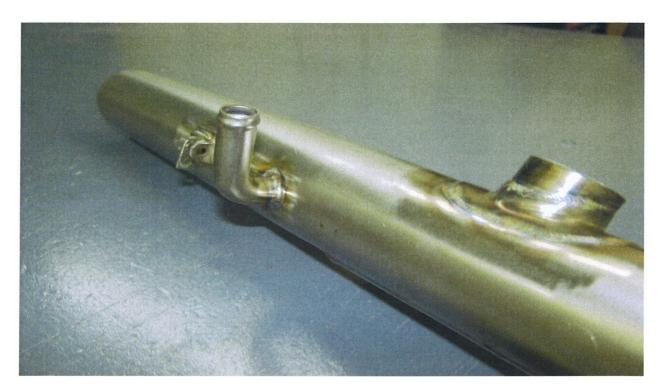
Figure 2 shows a close up of the contour of the Discharge Tube.

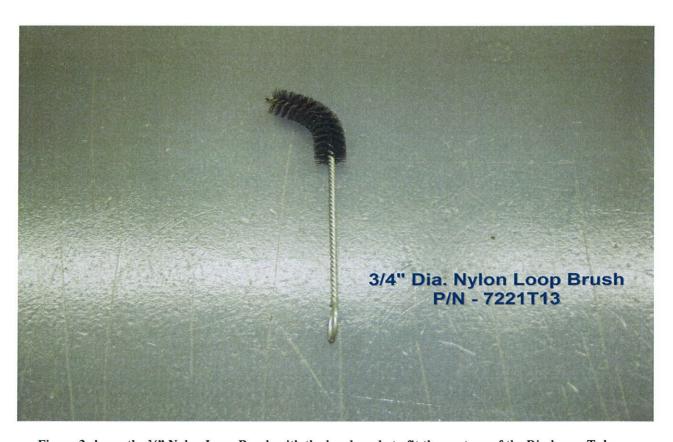
Figure 3 shows the 3/4" Nylon Loop Brush with the bend made to fit the contour of the Discharge Tube.

- With the clamp loose, carefully remove the Crankcase Oil Breather Hose from the Discharge Tube.
- Take the <sup>3</sup>/<sub>4</sub>" Nylon Loop Brush and insert it into Crankcase Oil Discharge Tube. You may find that bending the top section of the bristle portion of the brush to match the contour of the Discharge Tube aids greatly with insertion and removal of the brush (see Figure 3).
