Service Bulletin

TAT SB08-02

Model SR22 w/ Turbonormalizer

The purpose of this Service Bulletin is to inform affected owners and operators of the possibility for contact between the underside of the PRV/Y tube and the engine backbone resulting in metal erosion on the PRV/Y tube. This is primarily a problem that results from improper alignment of the PRV/Y tube during installation.

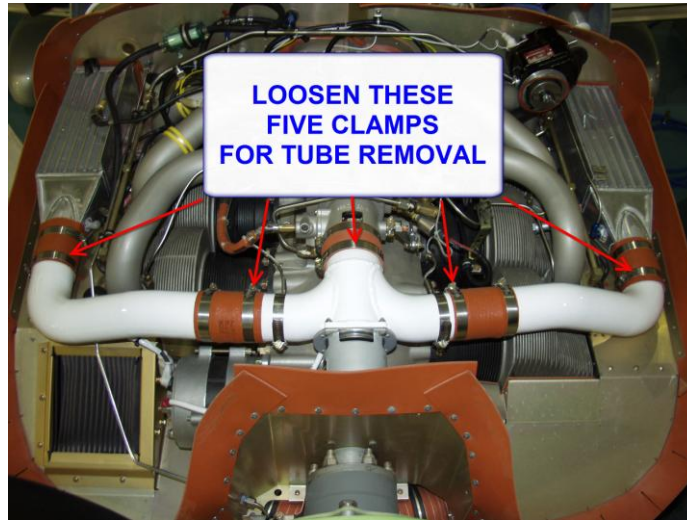
Figure 1 shows five clamps to be loosened to remove PRV/Y tube

- Gain access by removing the upper portion of cowl.
- Loosen clamps on induction couplings in five areas:
 1. Clamp closest to PRV/Y tube on coupling between PRV/Y tube and throttle body.

2. Clamp closest to PRV/Y tube on coupling between L/H induction tube and PRV/Y tube.
 3. Clamp closest to PRV/Y tube on coupling between R/H induction tube and PRV/Y tube.

4. Clamp closest to L/H induction tube on coupling between L/H induction tube and L/H intercooler.
 5. Clamp closest to R/H induction tube on coupling between R/H induction tube and R/H intercooler.

- With the clamps loose, carefully remove the PRV/Y tube from the three couplings connecting it with the throttle body and both induction tubes.
- Leave the loose clamps on the couplings as they will be used again upon re-installation.

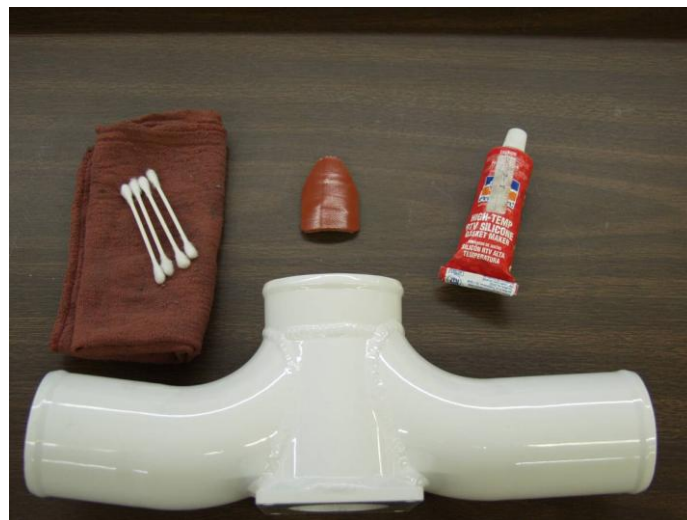
Figure 2 shows all material needed to attach the Anti-Wear Pad to the PRV/Y tube

PRV/Y Induction Tube	ETI-SR22-200-M2-1	1 ea
Anti-Wear Pad	22-6100025	1 ea
Red RTV Silicone	Not Provided	
Cotton Swabs	Not Provided

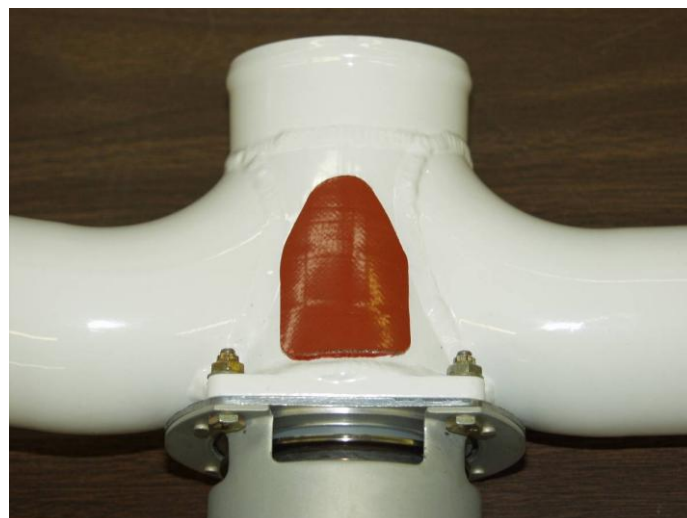
Figure 3 shows the Anti-Wear pad properly attached to the underside of the PRV/Y tube.

- The anti-wear pad is cut from curved stock so as to conform to the contour of the tube. It has a flat base and the upper corners clipped from the top.

- To apply the anti-wear pad, the induction tube should be placed on a flat workspace with the underside facing upwards.
- The tube must then be thoroughly cleaned to ensure good adhesion of the silicone.

- Apply Red RTV Silicone to the underside of the pad. Spread the glue evenly over the entire surface.
- Set the pad on the clean surface of the tube with the flat base of the pad up against, but not on top of the weld bead for the PRV flange.

- Apply pressure to the entire surface of the pad to ensure complete adhesion of the pad to the tube.
- There will be extra glue that squeezes from under the pad and collects at the sides of the pad. Use a cotton swab to clean up the extra glue.

- Set the tube somewhere where it can sit undisturbed for the next 12-24 hours to allow the silicone to fully cure.
- After the RTV silicone has fully cured, inspect the pad once more to ensure all edges of the pad are fully secured to the tube. If so, then the tube is ready to be re-installed on the engine.
